CONTROL OF SEDIMENT DISCHARGES  
AND WATER QUALITY BELOW RECREATION  
RELATED ROADS

Final Report

Eisenhower Consortium  
Cooperative Agreement No. 16-587-GR

University of Wyoming  
Department of Civil and Architectural Engineering  
Laramie, Wyoming  
September, 1978

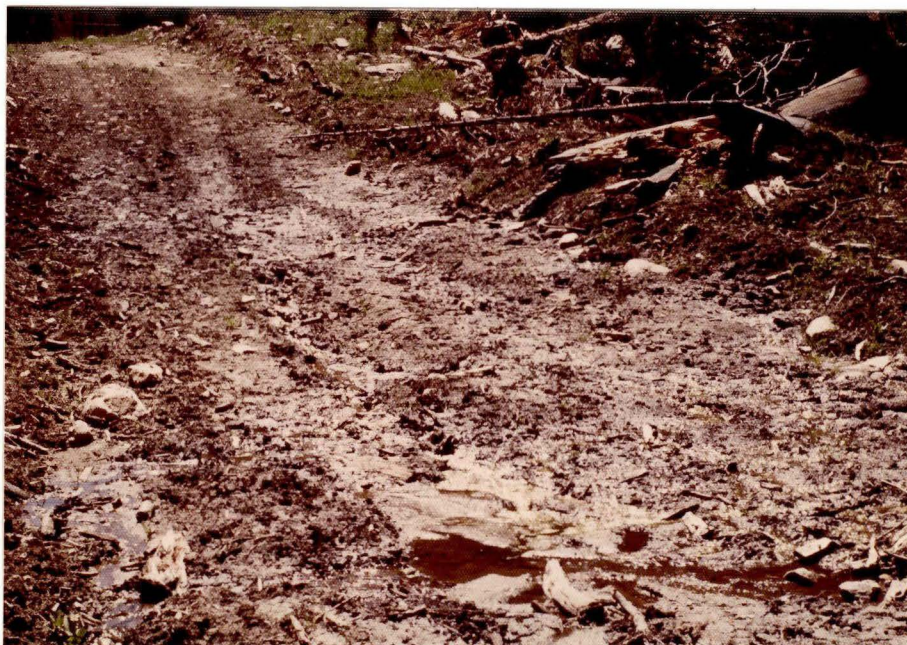
When vegetation is stripped away, the soil is exposed and may be eroded both from the road surface and side slopes by the action of wind, rain or snowmelt (ASCE, 1965). Figure 1 shows the results which have

Figure 1. Road Surface Erosion on Spring Creek Road, 1977.

occurred to a timber harvest road in the Medicine Bow National Forest one year after stripping away the vegetation. The road has not been completed. Timber harvesting is increasing along with the demand for recreational use in the forests of the Western United States resulting in increased road construction activities. Thus, there is the potential for increased deleterious effects on the surrounding environment and stream water quality in these forested areas where new and upgraded road construction activities are occurring.

Field investigations of both new and existing roads indicated that almost all the sediment movement which occurs is the result of road construction and the associated logging practices. Figure 13 shows erosion which occurred on the fill slope of the Sheep Creek Road at the end of a water bar. Concentration of the runoff water at this point was a major factor in the erosion process. Figure 1 showed road erosion where the

road was not maintained and construction left for a period of time. In almost all cases where existing roads were analyzed, most of the sediment movement was from the cut and fill slopes of the disturbed road material and the road itself. Where the material above and below the road was undisturbed by road construction activity, minimal amounts of sediment were moved from these areas. In most draws and vegetated channel areas, the main movement of material was organic matter (leaves, pine needles, etc.) in the undisturbed areas.

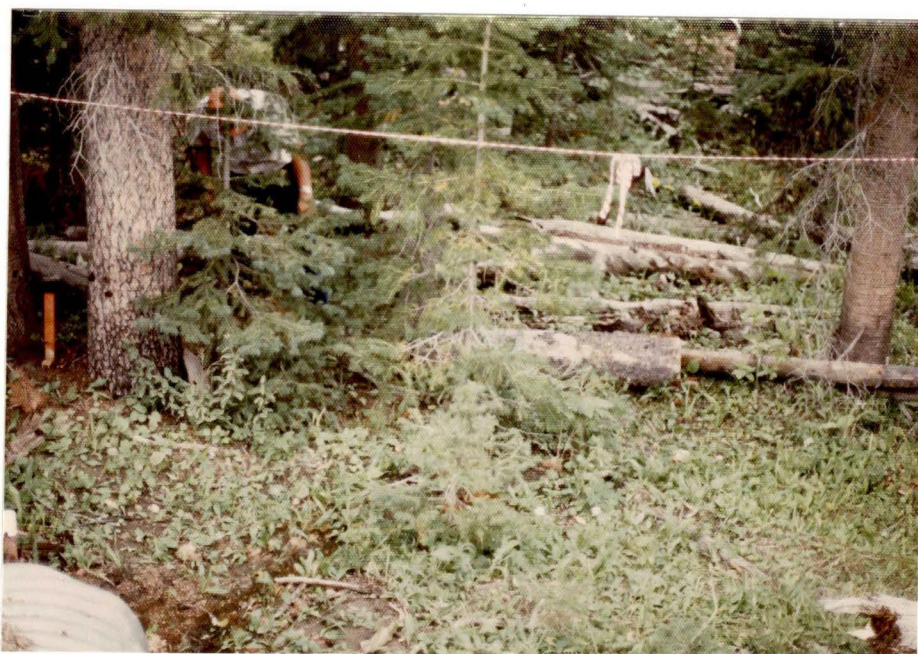
Figure 4 shows a natural vegetation and low-lying shrubbery study site on the Sheep Creek Road. The only modifications done to a natural type site is to construct a barrier (dam) at some distance downstream (50 to 100 feet) of the site to trap any material not trapped by the vegetative cover.

Figure 4. Natural vegetation and low-lying shrubbery control structure on the Sheep Creek Road.

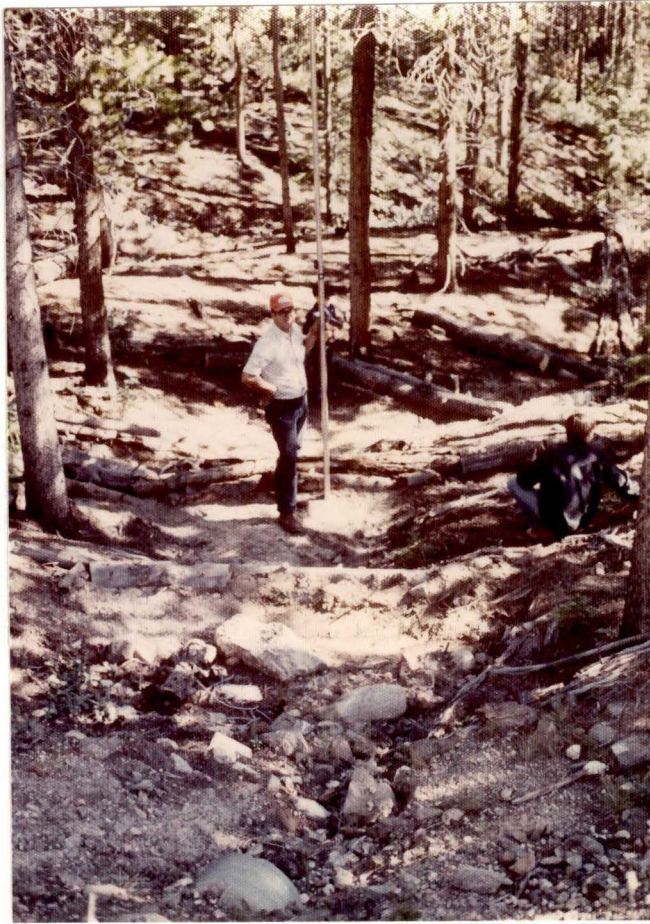
Figure 5. Log structure placed in drainage bottom located on the Sheep Creek Road.

Figure 5 shows a log structure constructed on the study areas. The dead fall logs are cut and placed in the drainage to form a log structure and a series of these log structures are placed down the drainage. A barrier (dam) is constructed below the series of log structures. Natural deadfall and live trees are used in connection with the log structures. The live trees are used for support where possible and also allow for higher log structures to be erected.

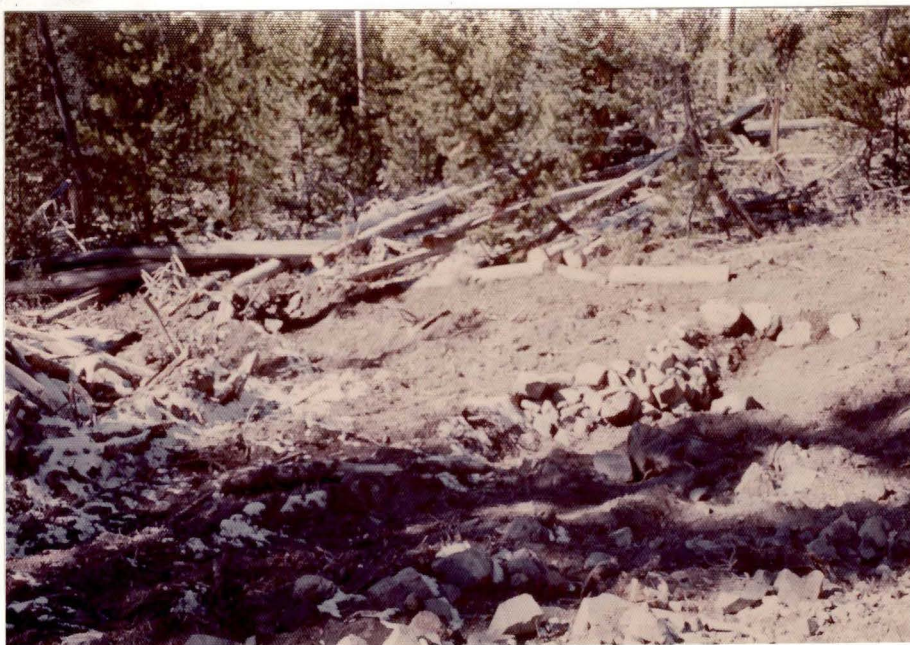
Figure 6 shows a catch basin constructed on a steep fill slope on the Sheep Creek Road. It is lined with rock for scour protection. The

Figure 6. Depression basin on a steep fill slope on the Sheep Creek Road.

depression (catch basin) was created by the construction equipment in constructing the road. The actual basin was shaped by shoveling to fit the contour area.

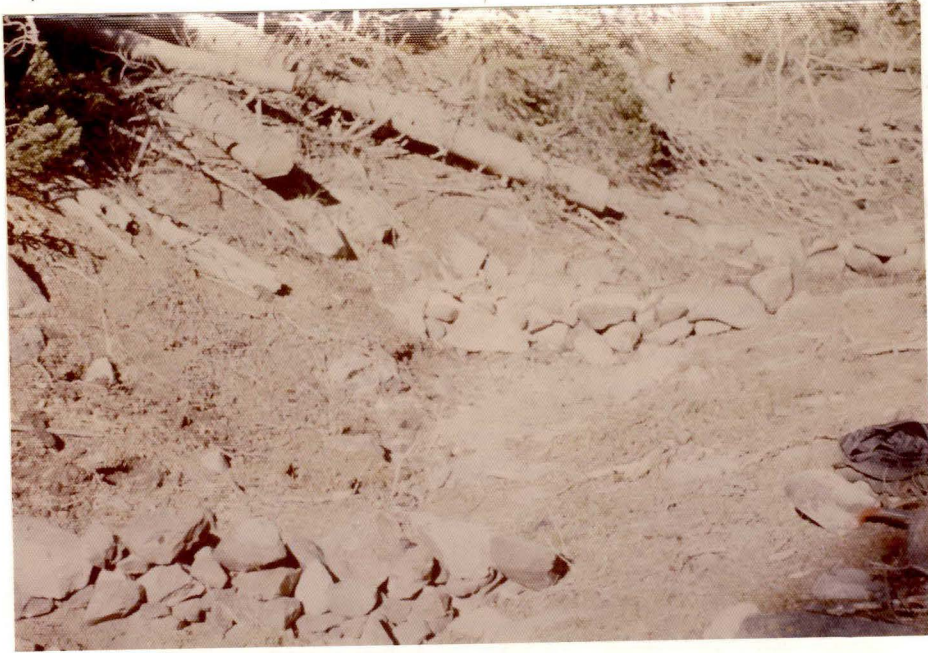
The last class of structures, rocks, earth mounds and gabions, have a variety of ways for construction. Figure 7 shows a rock structure constructed in a manner similar to the log structure of Figure 5. Rocks are piled against other larger rocks and dead fall material to create the series of rock structures. Figure 8 shows a gabion structure. A log support structure is constructed against which is placed a wire mesh structure filled with 1/4 to 1 inch gravel material. The gabion structure does not fit into the surrounding environment as well as the other structures.

Figure 7. Rock barrier control structure located on the Spring Creek Road.

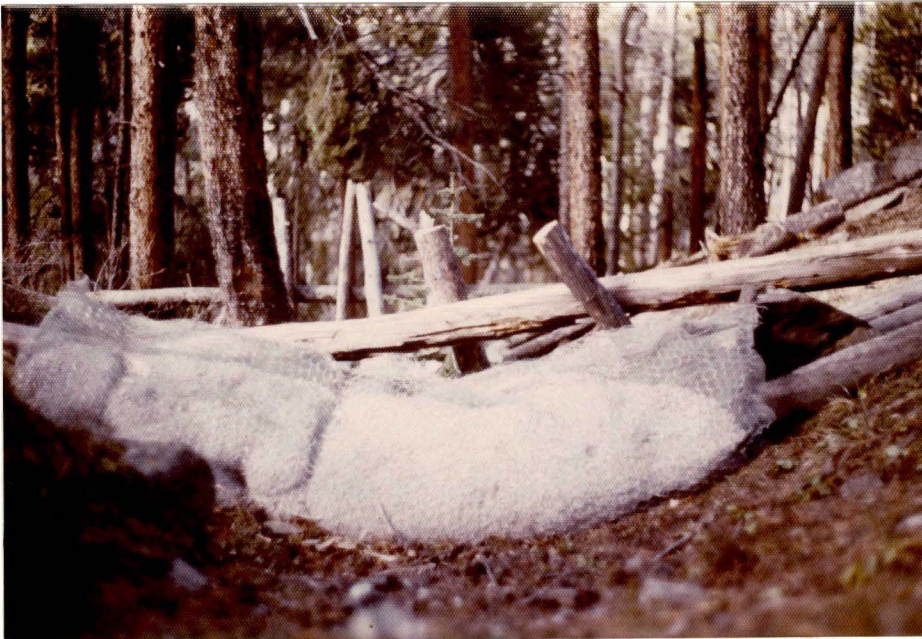
Figure 8. Gabion type control structure located on the Sheep Creek Road.

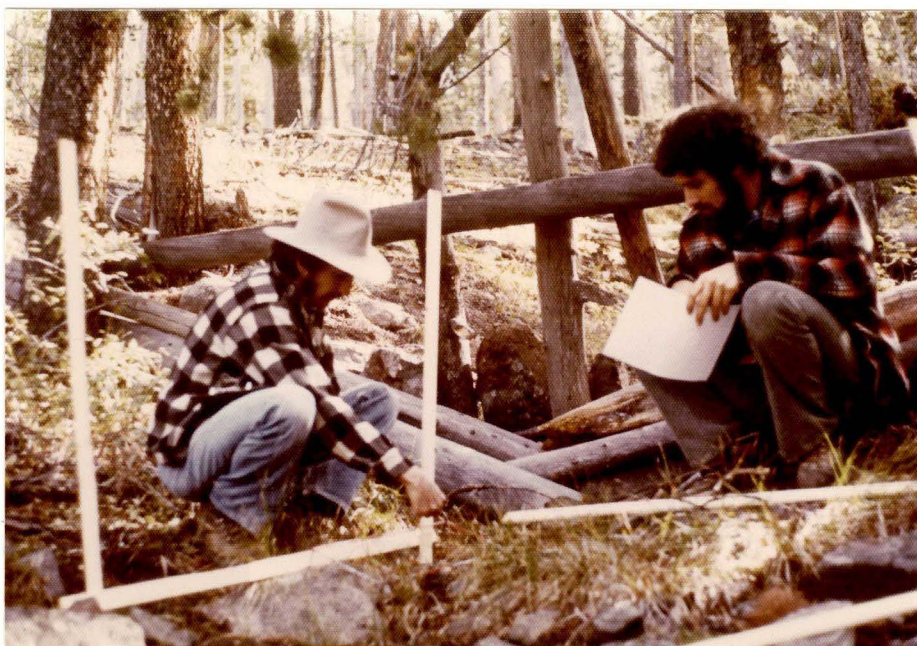
Vegetation plots have been established at selected places within each study area for determining cover density and types of plants initially existing in the study area. A field qualitative survey of site vegetation was accomplished at the two study areas by a botanist graduate student. A quantitative study using a canopy coverage method of vegetation analysis was also started in the fall of 1976 (Northwest Science 33:43 1959). Figure 9 shows one of the plant study enclosures on the Sheep Creek Road. Further analysis on the canopy coverage method has not been completed since that time.

Figure 9. Plant study enclosure located on the Sheep Creek Road.

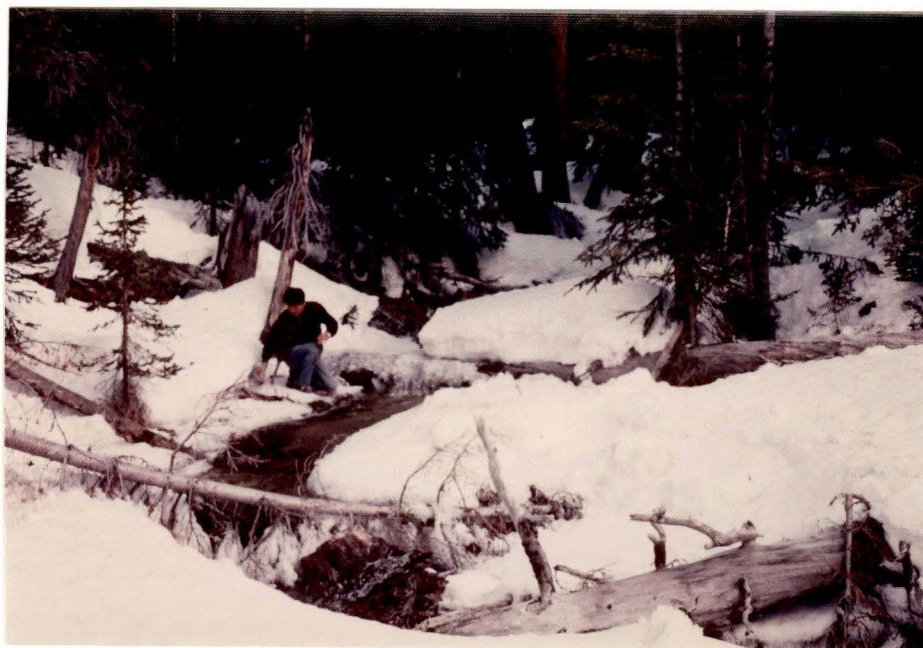
Assessing the impact of road construction and sediment control on water quality was attacked from both a field and laboratory approach. Field grab water samples (Figure 12) were collected in flowing water near roadway sites at points above and below the road. Above road sampling

Figure 12. Obtaining a water quality grab sample on the Spring Creek Road.

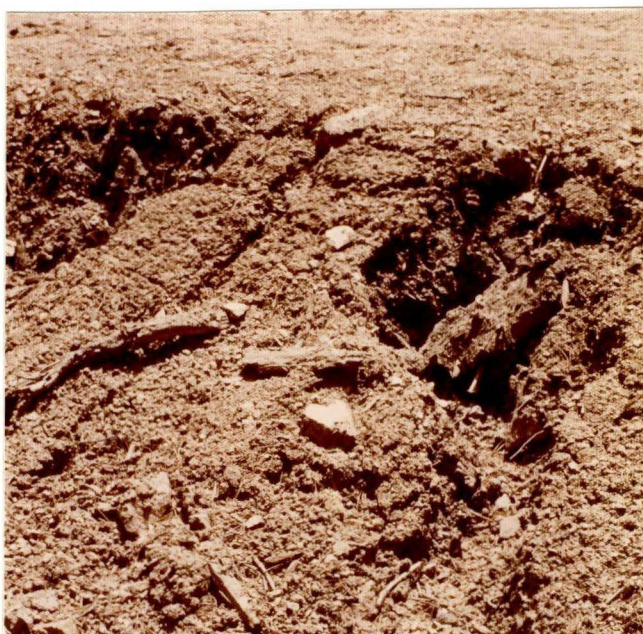
Figure 13. Erosion of the fill slope on the Sheep Creek Road - 1977.

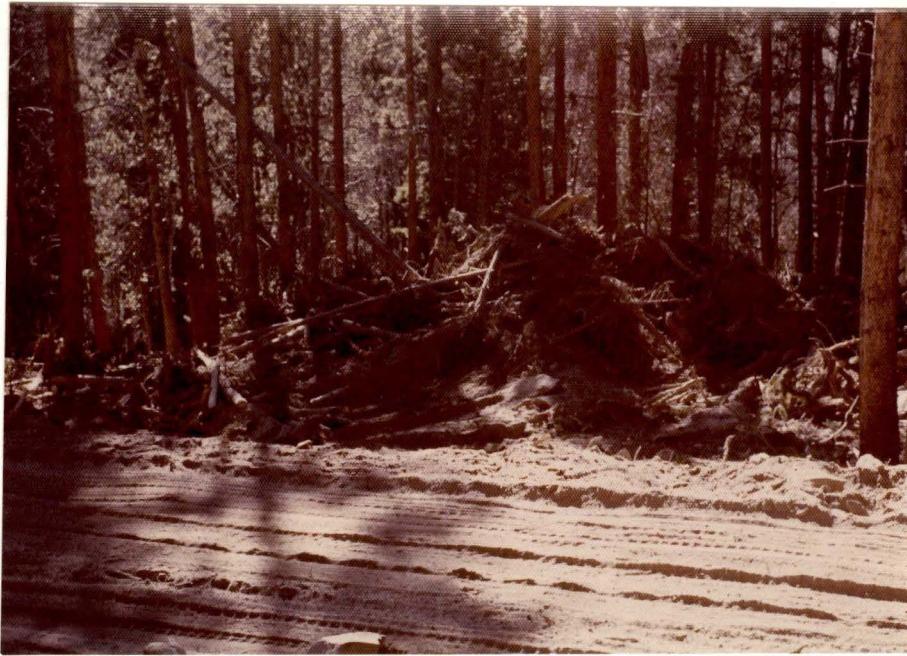
Construction practices can many times contribute large amounts of sediment and organic matter to nearby streams and vegetated channels. This was quite apparent on the Sheep Creek Road and Spring Creek Road where the contractor was allowed to push slashpiles from clearing and grubbing into the bottom of drainage channels below the road (Figure 14). Once the slashpiles were burned, noticeable amounts of burned organic material (ash) and sediment contained within the slashpiles had been transported downslope. In one case, material was found about one-quarter mile downstream where it entered into a larger perennial drainage. This problem could be alleviated by placing the slashpiles on the ridges

Figure 14. Slashpile on Sheep Creek Road situated in drainage bottom.

and in flat areas where water action would not be as detrimental to the movement of the ash and soil material.
